existing condition survey
unit one buildings
volume 2
appendix D

ELLIS ISLAND
STATUE OF LIBERTY

EXISTING CONDITION SURVEY
UNIT ONE BUILDINGS

Appendix D

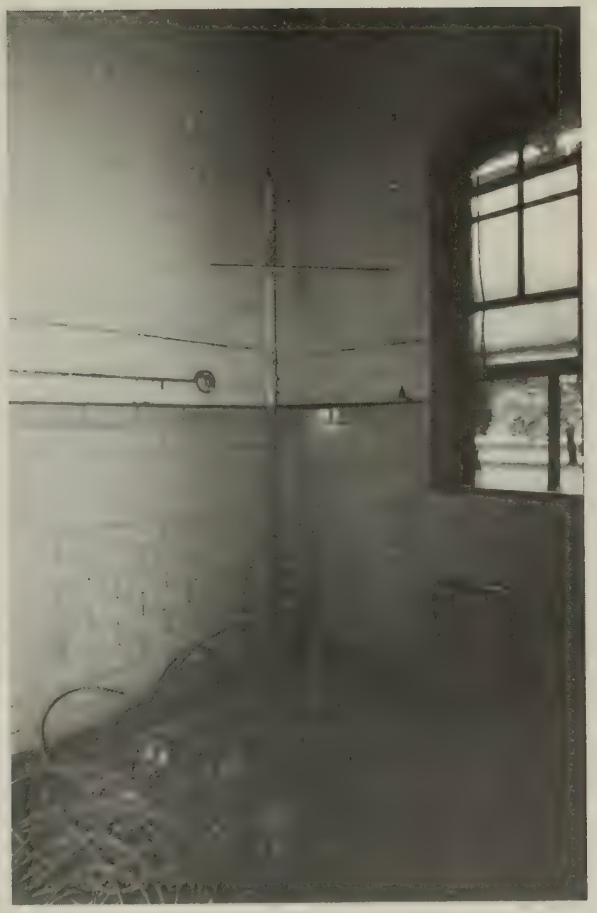
ROOM NO. 114

NW - COOLED DOOR - LEFT

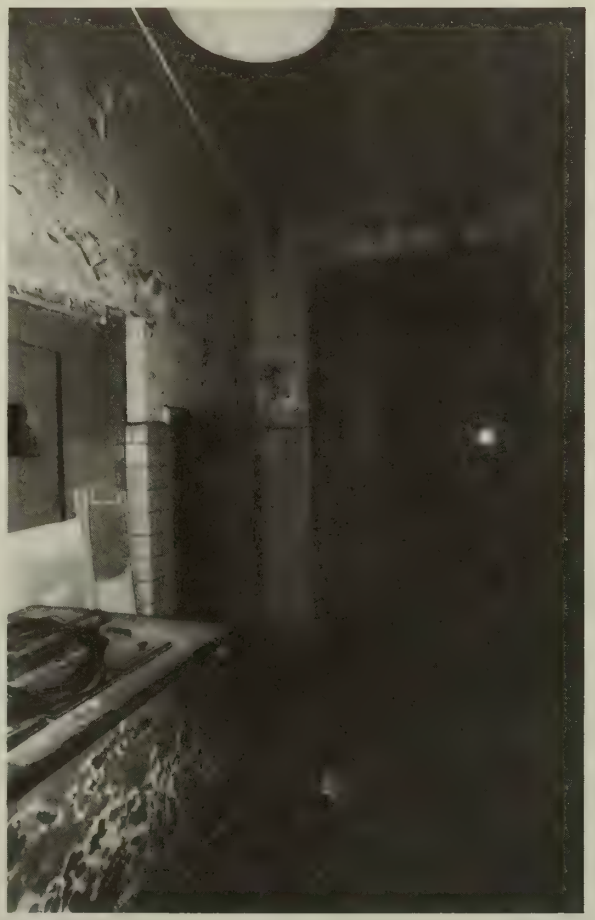
PHOTOGRAPHS: ROOM NO. 117

S.W. END - DOOR TO RM. 118

N.W. CORNER

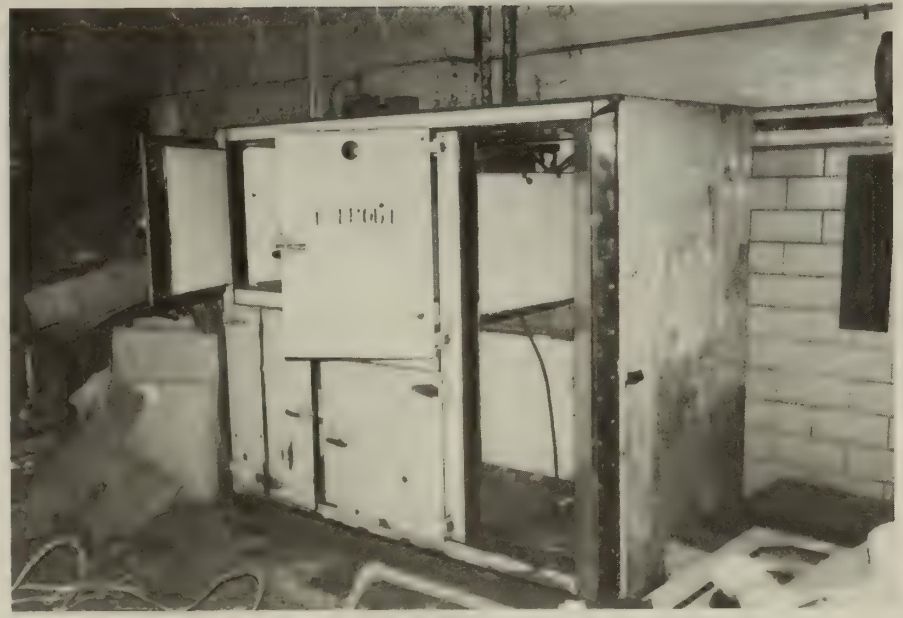
ROOM NO. 117

STOVE - N. WALL

ENAMELED METAL ICE BOX - N. WALL

WOODEN ICE BOX - S. WALL

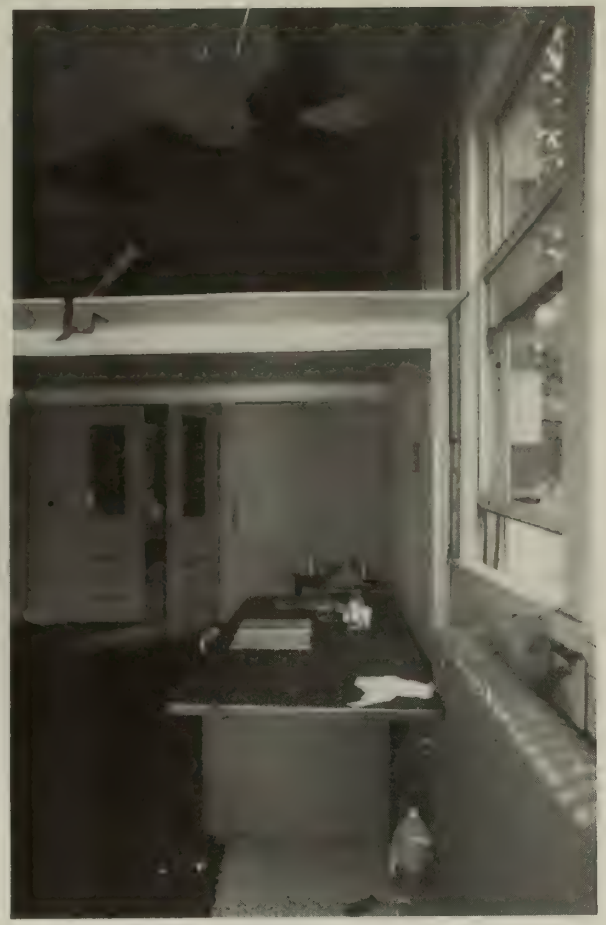
PHOTOGRAPHS: ROOM NO. 118

VIEW N. ALONG E. WALL

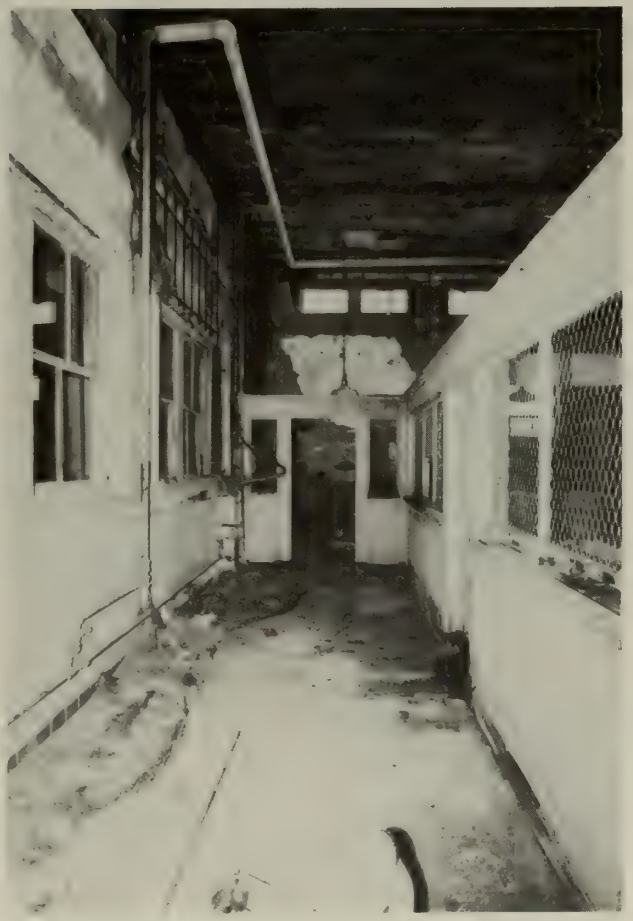
PHOTOGRAPHS: ROOM NO. 119

VIEW E. FROM COUNTERS

VIEW W. FROM E. END OF COUNTERS

S. WALL - DOORS FROM H104

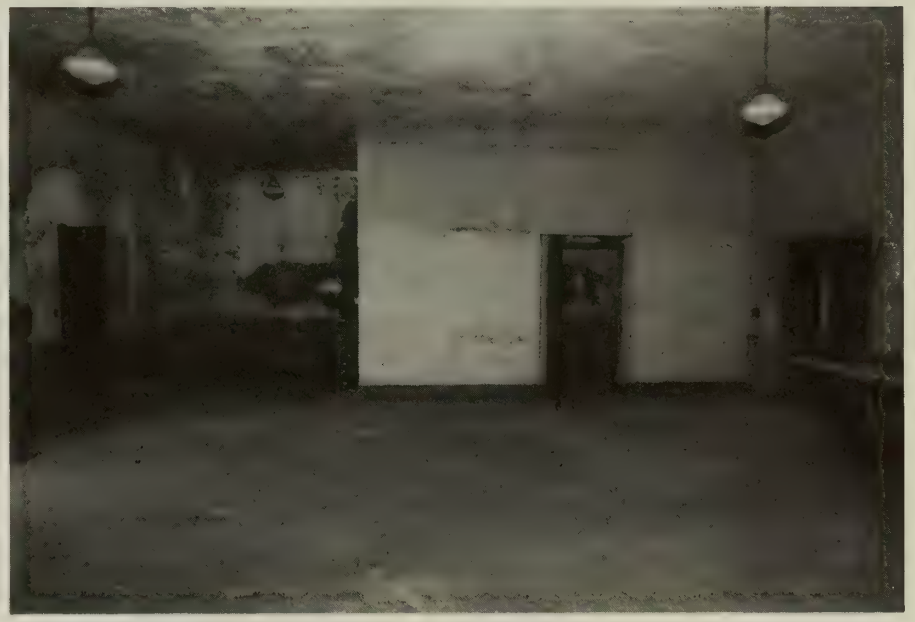
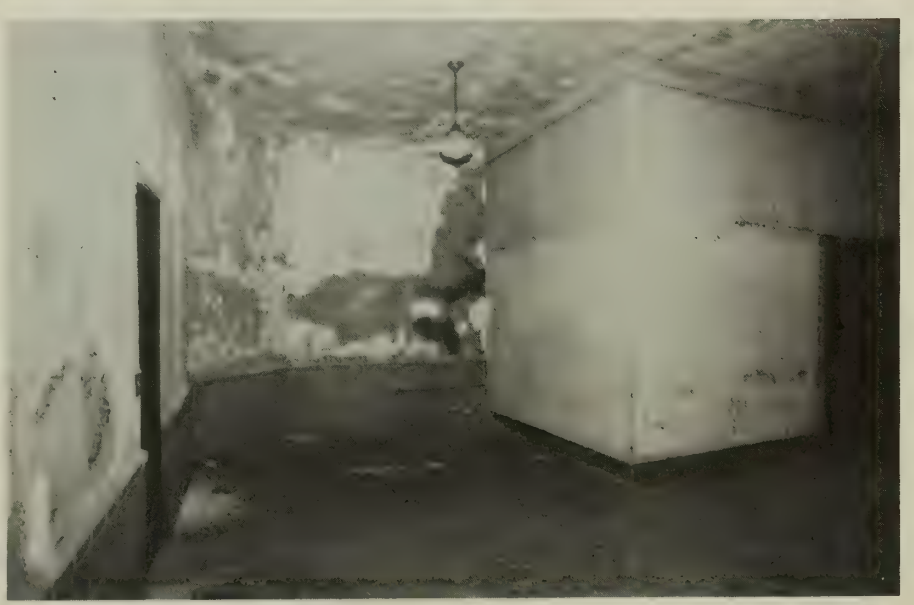
ROOM NO. 203

VIEW S.

VIEW N.

VIEW S.E

N.W. CORNER

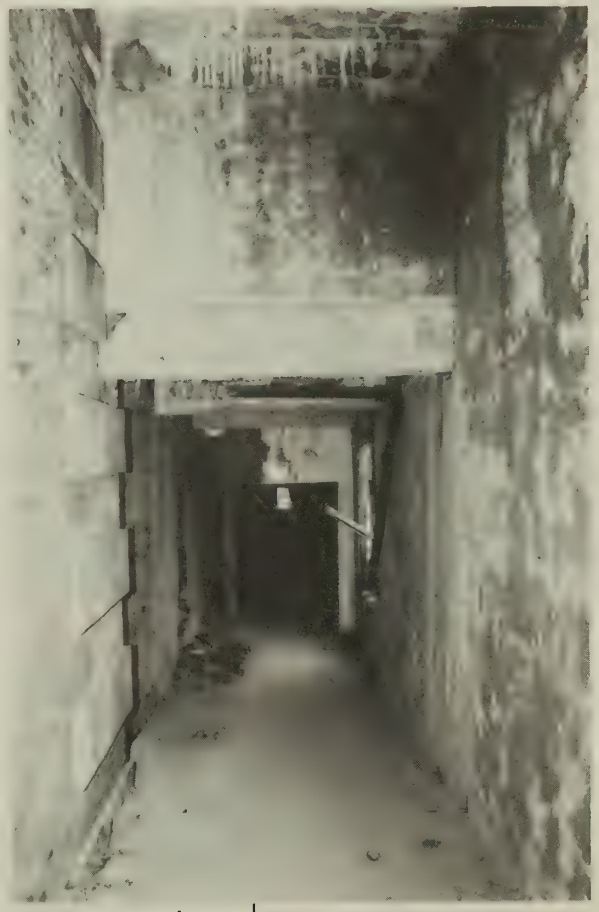
ROOM NO. H201

VIEW E.

VIEW W.

VIEW W. END INTO B+C BLDG.

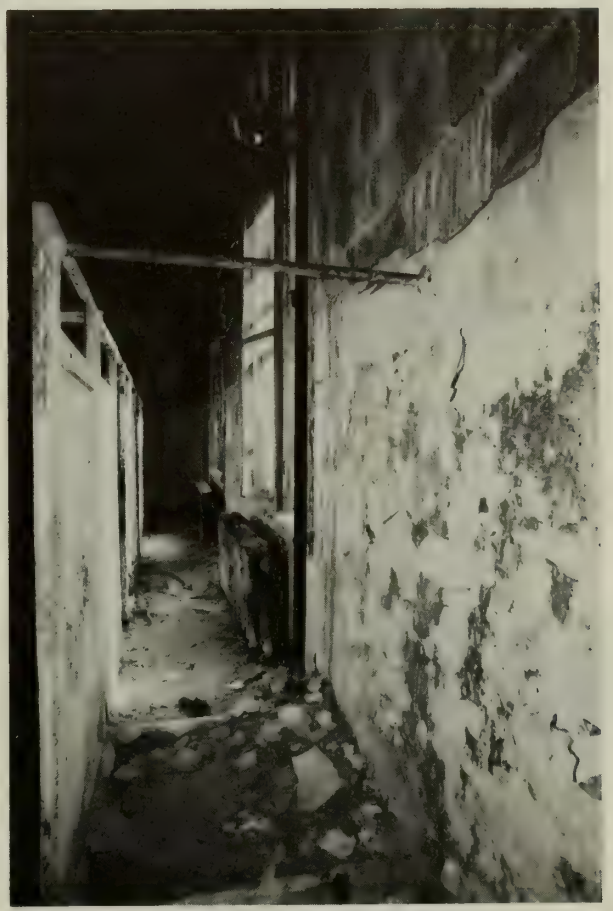
PHOTOGRAPHS: ROOM NO. 110

LOCKERS

VIEW N. ALONG E. WALL

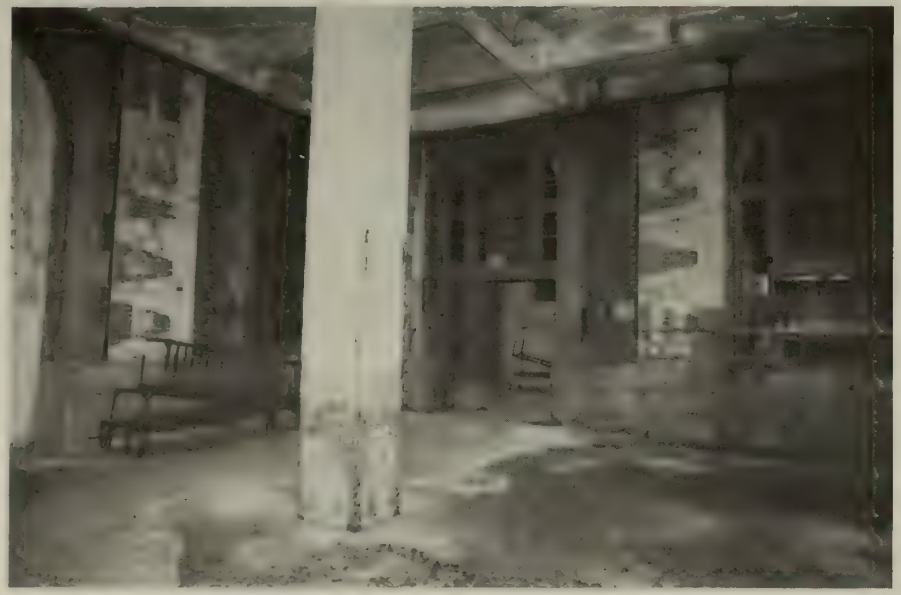
ROOM NO. 122

S.E. CORNER

N.W. CORNER

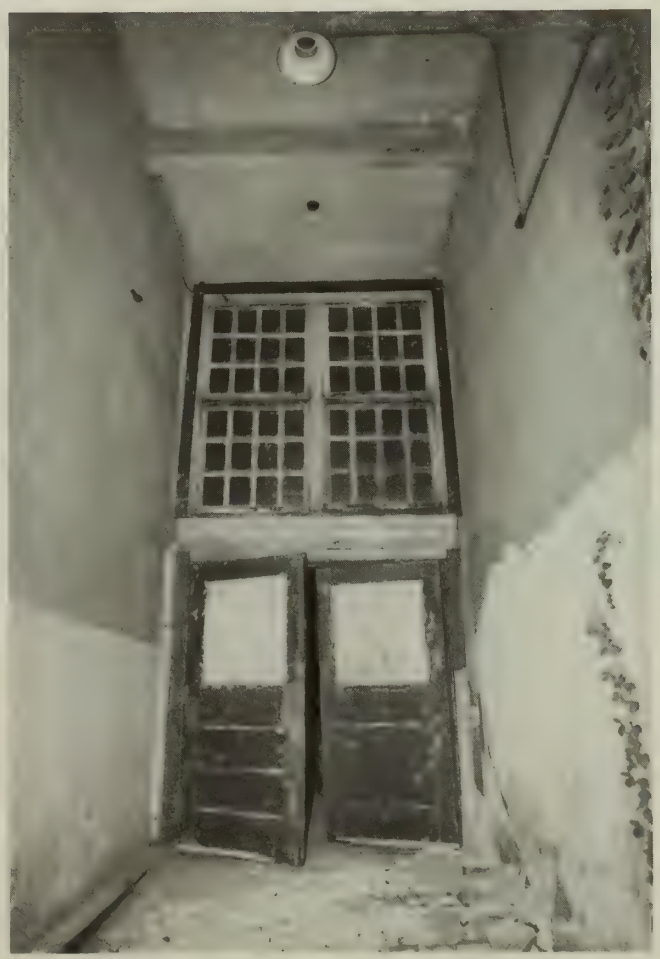
ROOM NO. 124

VIEW S.

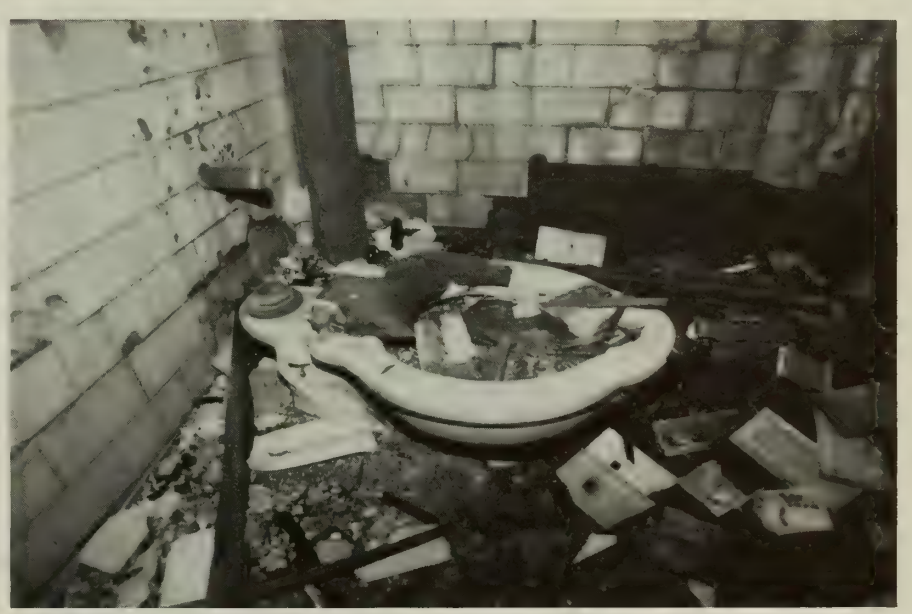
ROOM NO. 305A

FINISHES:	CONDITION:	DATE:	NOTES:
FLOOR:	[X] Tile [ ] Vinyl [ ] Concrete [ ] Other:	[ ] Good [ ] Fair [ ] Poor [ ] Destroyed	[ ] 1909-1912 [X] 1913-1923 [ ] 1924-1938 [ ] 1939-Present	DEBRIS
BASE:	[ ] Wood [ ] Tile [X] Tile Wainscot [ ] Other:	[ ] Good [X] Fair [ ] Poor [ ] Destroyed	[ ] 1909-1912 [X] 1913-1923 [ ] 1924-1938 [ ] 1939-Present	7'- MISSING TILES - N & E DISCOLORED
WALLS:	[X] Plaster [ ] Gypsum Board [ ] Partitions [ ] Other:	[ ] Good [ ] Fair [ ] Poor [X] Destroyed	[ ] 1909-1912 [X] 1913-1923 [ ] 1924-1938 [ ] 1939-Present	N+W - EXPOSED T.C.
CEILING:	[X] Plaster [ ] Acoustic panels [ ] Cove [ ] Other	[ ] Good [X] Fair [ ] Poor [ ] Destroyed	[ ] 1909-1912 [X] 1913-1923 [ ] 1924-1938 [ ] 1939-Present	
DOORS/ OPENINGS:	[ ] Wood/Glass Panelled [ ] Wood Veneer [X] Galvanized Metal [ ] Other:	[ ] Good [ ] Fair [X] Poor [ ] Destroyed	[ ] 1909-1912 [ ] 1913-1923 [X] 1924-1938 135 [ ] 1939-Present	OBSCURE GLASS PANE BASE CORRODED AWAY

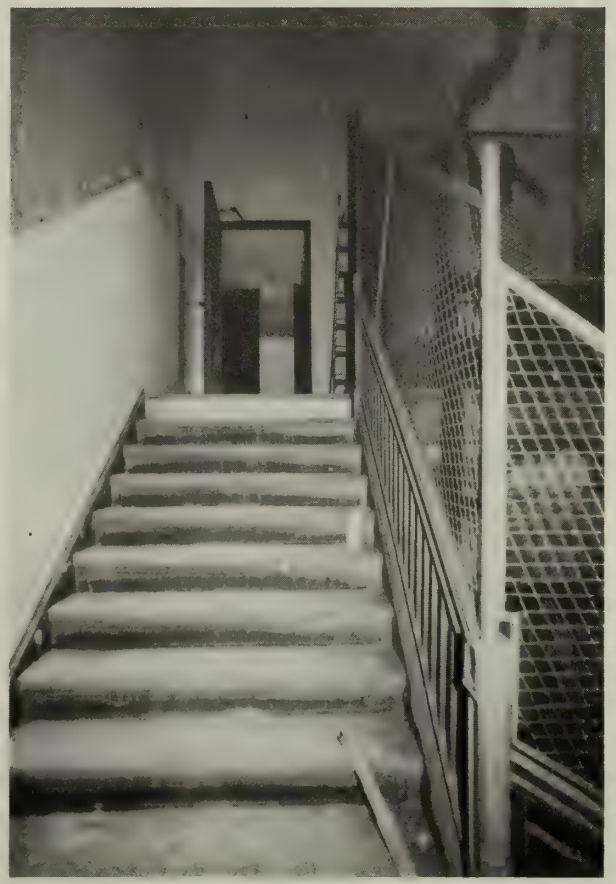
ROOM NO. 501

VIEW E. UP TO THIRD FLOOR LANDING.

VIEW W. FROM THIRD FLOOR LANDING.

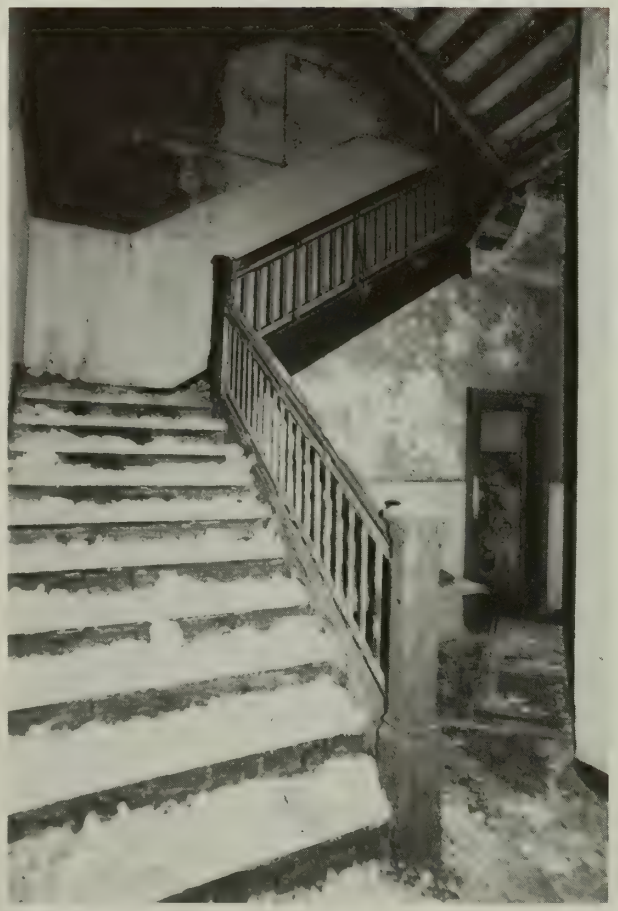
ROOM NO. 502

FOOT OF STAIR - VIEW N.

VIEW N.W.

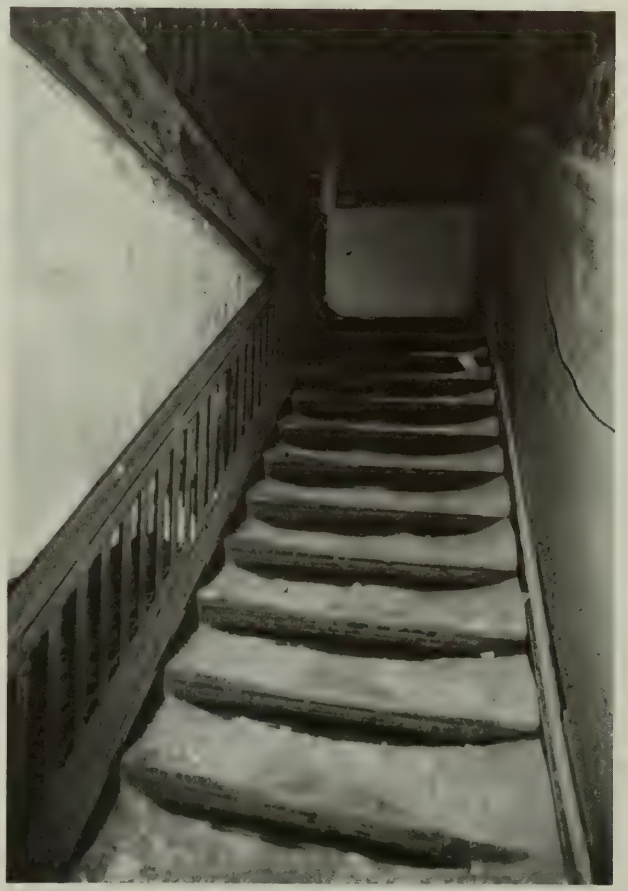
ROOM NO. 503

VIEW NW UP TO THIRD FLOOR

VIEW W. TO THIRD FLOOR

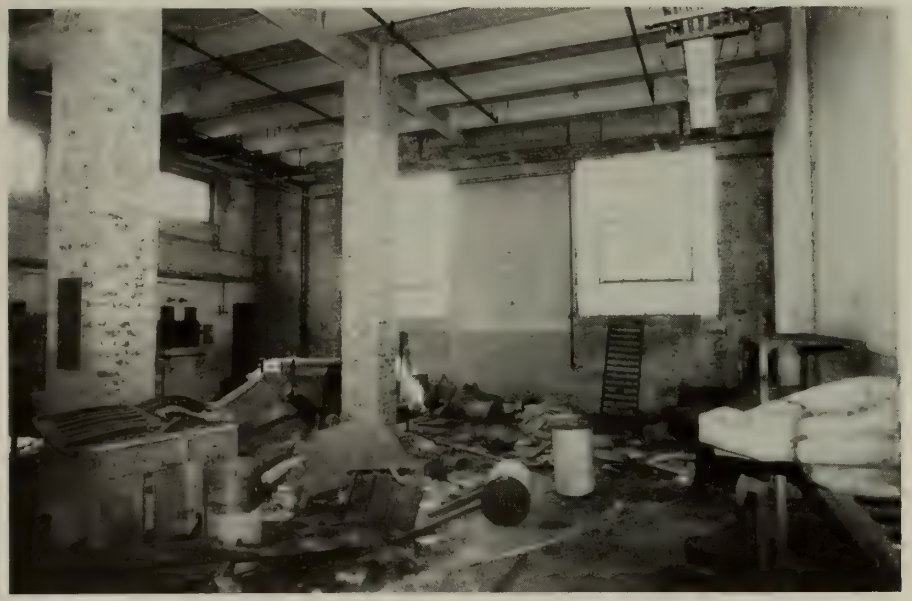
ROOM NO. 101

VIEW S.W.

S. WALL - OVEN LOADING HOOD

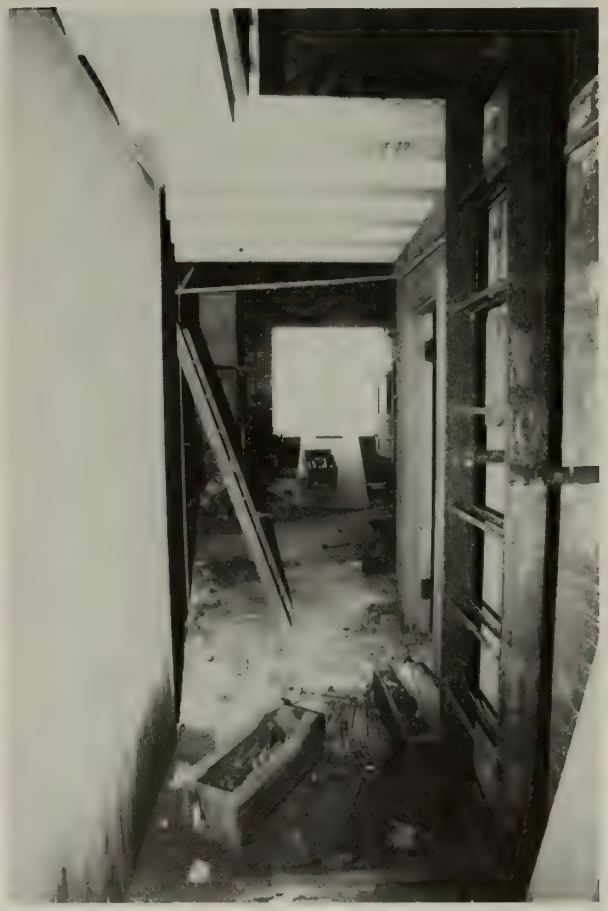
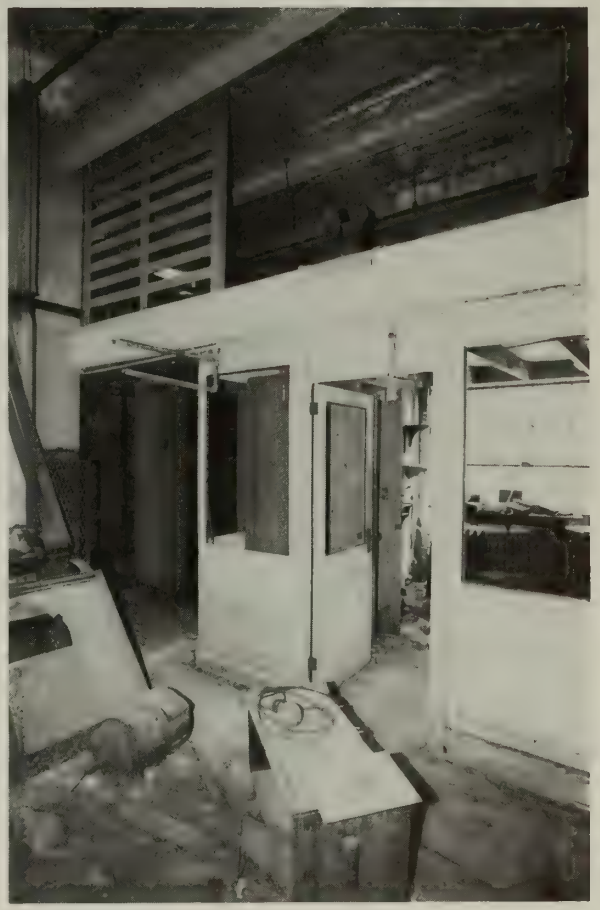
ROOM NO. 203

VIEW W.

VIEW NE. - WOOD DECK

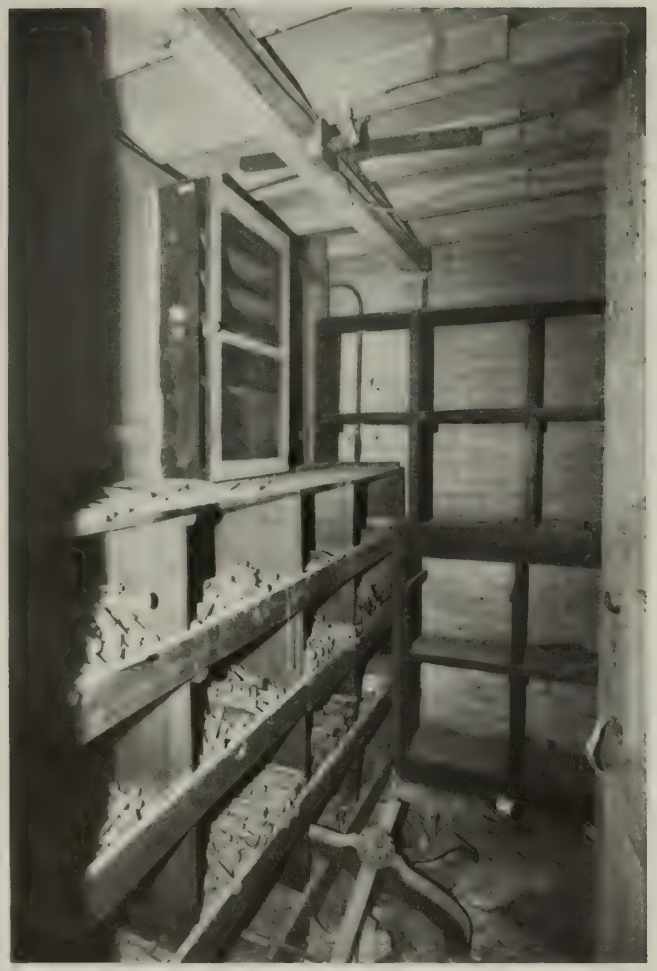
ROOM NO. 203B

VIEW NE FROM DOOR

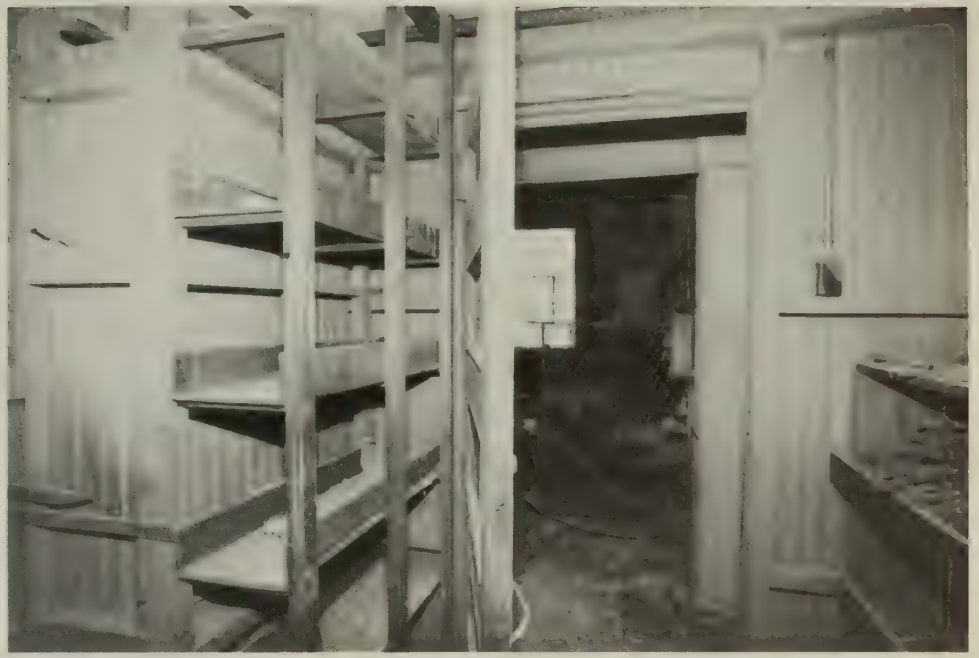
VIEW W.

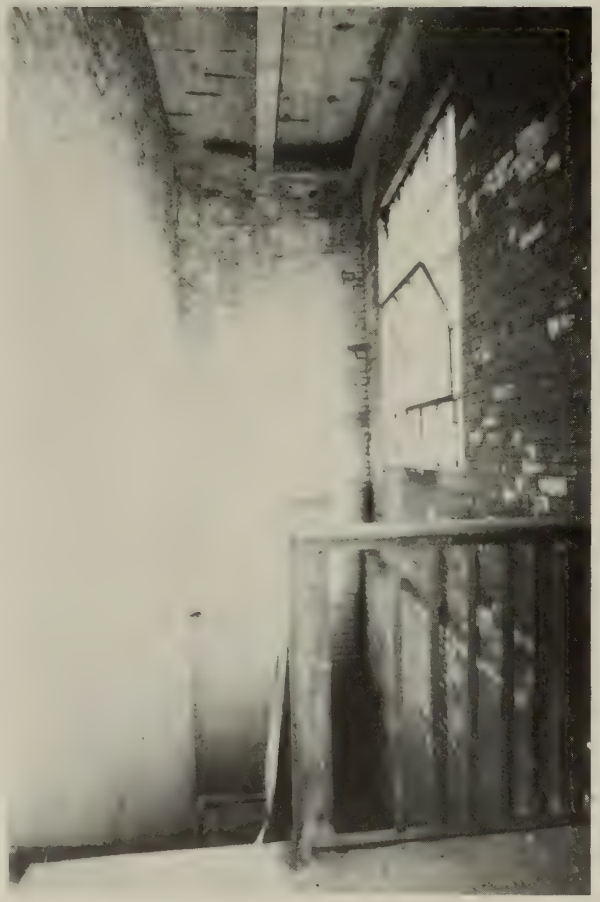
ROOM NO. S01

Floor: Fair condition. Surface corroded and pitted.

Base: Surface corrosion and flaking.

Walls: Peeling paint and long vertical crack in north wall.

Ceiling: Fair condition. Areas of exposed reinforcing bars where concrete has spalled off.

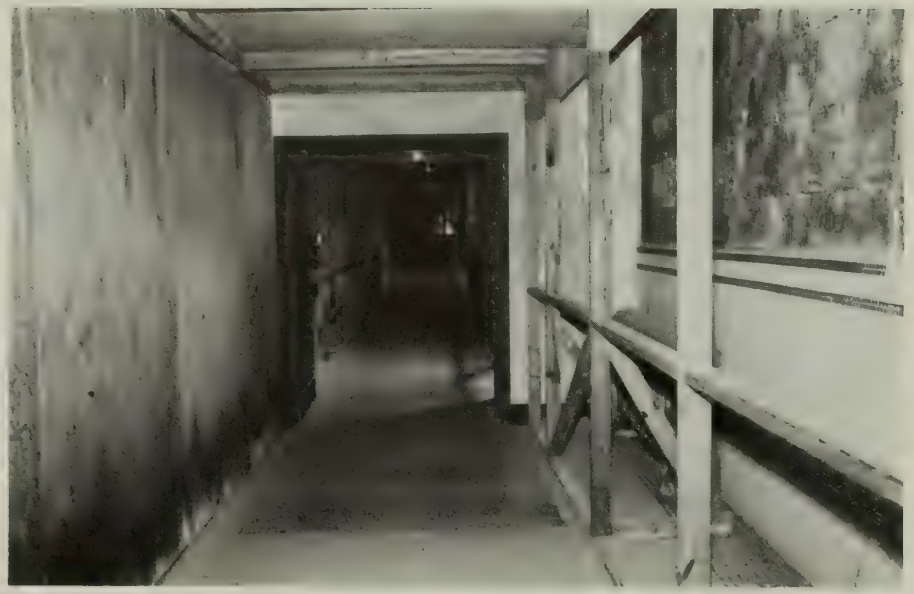
PHOTOGRAPHS: ROOM NO. 201

Ceiling: Very poor condition. Areas of exposed and falling metal lath.

Doors/Openings: Right door panels replaced with ply at entry door. Edges very worn and hardware missing. Edges corroded and hardware missing on galvanized doors.

VIEW E. FROM ENTRY TO K&L BLDG.

VIEW W. FROM E. END

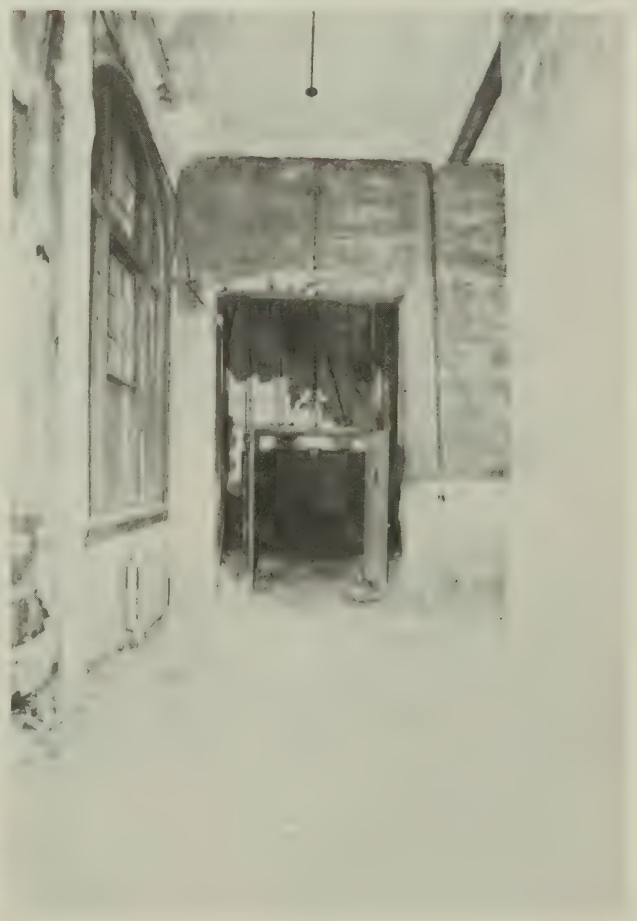
ROOM NO. 101

FINISHES:	CONDITION:	DATE:	NOTES:
FLOOR:	[X] Tile [ ] Vinyl [ ] Concrete [ ] Other:	[ ] Good [ ] Fair [ ] Poor [ ] Destroyed	[X] 1909-1912 [ ] 1913-1923 [ ] 1924-1938 [ ] 1939-Present	DEBRIS
BASE:	[ ] Wood [ ] Tile [X] Tile Wainscot [ ] Other:	[ ] Good [ ] Fair [X] Poor [ ] Destroyed	[ ] 1909-1912 [ ] 1913-1923 [ ] 1924-1938 [ ] 1939-Present	N.- DESTROYED W.- EXP. T.C. E.- GREEN DISCOLOR., CHIPPING
WALLS:	[X] Plaster [ ] Gypsum Board [ ] Partitions [ ] Other:	[ ] Good [ ] Fair [ ] Poor [X] Destroyed	[X] 1909-1912 [ ] 1913-1923 [ ] 1924-1938 [ ] 1939-Present	ALL EXP. T.C. EXCEPT S. WALL- GOOD
CEILING:	[X] Plaster [ ] Acoustic panels [ ] Cove [ ] Other	[ ] Good [ ] Fair [ ] Poor [X] Destroyed	[X] 1909-1912 [ ] 1913-1923 [ ] 1924-1938 [ ] 1939-Present	PARGING FINISH GONE EXPOSED REINF. BARS IN CONCRETE
DOORS/ OPENINGS:	[ ] Wood/Glass Panelled [X] Wood Veneer [X] Galvanized Metal [ ] Other:	[ ] Good [ ] Fair [X] Poor [ ] Destroyed	[ ] 1909-1912 [ ] 1913-1923 [ ] 1924-1938 [X] 1939-Present	S+N- DOUBLE DR.- SMALL GLASS @ S. -MISSING HARDWARE W. - WIRE GLASS VENEER SEPARATING AT BASE

N. DOORS

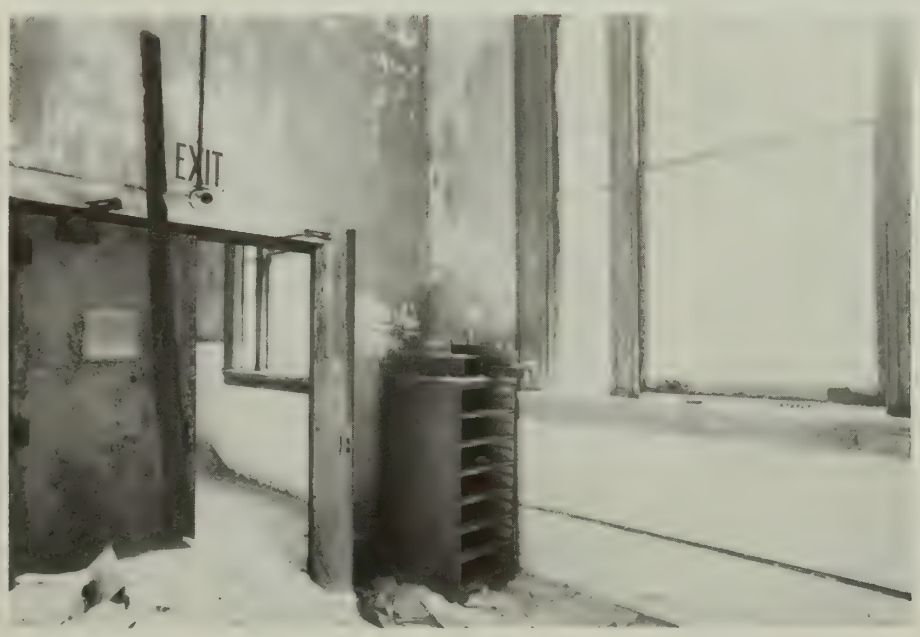
ROOM NO. 102

FINISHES:	CONDITION:	DATE:	NOTES:
FLOOR:	☐ Tile ☒ Vinyl ☐ Concrete ☐ Other:	☐ Good ☐ Fair ☐ Poor ☐ Destroyed	☐ 1909-1912 ☐ 1913-1923 ☒ 1924-1938 ☐ 1939-Present	DEBRIS OVER TILE
BASE:	☐ Wood ☐ Tile ☒ Tile Wainscot ☐ Other:	☐ Good ☒ Fair ☐ Poor ☐ Destroyed	☒ 1909-1912 E+W ☐ 1913-1923 ☐ 1924-1938 ☐ 1939-Present	5'- E+W - PAINTED E.- MISSING TILES
WALLS:	☒ Plaster N, E, W ☒ Gypsum Board S. ☐ Partitions ☐ Other:	☐ Good ☒ Fair ☐ Poor ☐ Destroyed	☒ 1909-1912 E+W, N ☐ 1913-1923 ☒ 1924-1938 S. ☐ 1939-Present	W.- EXP. TO T.C. E.- FLAKING N+S- PP
CEILING:	☒ Plaster ☐ Acoustic panels ☐ Cove ☐ Other	☐ Good ☐ Fair ☐ Poor ☒ Destroyed	☒ 1909-1912 ☐ 1913-1923 ☐ 1924-1938 ☐ 1939-Present	EXP. REINF. CONCRETE
DOORS/ OPENINGS:	☐ Wood/Glass Panelled ☐ Wood Veneer ☒ Galvanized Metal ☐ Other:	☐ Good ☐ Fair ☒ Poor ☐ Destroyed	☐ 1909-1912 ☐ 1913-1923 ☐ 1924-1938 ☐ 1939-Present	1- N.- DOUBLE DR.- W/ SMALL WIRE GLASS PANES NO HARDWARE, PP

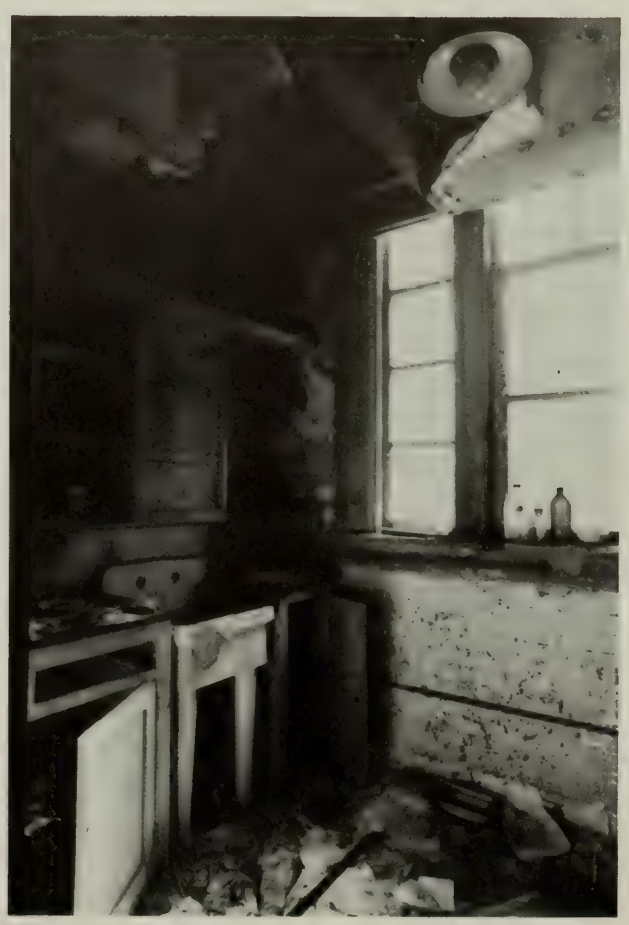
ROOM NO. 103

FINISHES:	CONDITION:	DATE:	NOTES:
FLOOR:	[ ] Tile [X] Vinyl [ ] Concrete [ ] Other:	[ ] Good [ ] Fair [ ] Poor [ ] Destroyed	[ ] 1909-1912 [ ] 1913-1923 [X] 1924-1938 [ ] 1939-Present	DEBRIS
BASE:	[X] Wood SW [ ] Tile [X] Tile Wainscot E. [ ] Other:	[X] Good E. [ ] Fair [ ] Poor [X] Destroyed S+W	[X] 1909-1912 E. [ ] 1913-1923 [X] 1924-1938 W,S [ ] 1939-Present	E.- PAINTED TILE - PEELING N - NOT VISIBLE
WALLS:	[X] Plaster E. [X] Gypsum Board [ ] Partitions [ ] Other:	[X] Good PLASTER [X] Fair [ ] Poor [ ] Destroyed	[X] 1909-1912 E. [ ] 1913-1923 [X] 1924-1938 [ ] 1939-Present	
CEILING:	[ ] Plaster [ ] Acoustic panels [ ] Cove [X] Other G. BOARD	[ ] Good [ ] Fair [X] Poor [ ] Destroyed	[ ] 1909-1912 [ ] 1913-1923 [X] 1924-1938 [ ] 1939-Present	EXPOSED WOOD FRAME CRUMBLING
DOORS/ OPENINGS:	[X] Wood/Glass Panelled [ ] Wood Veneer [ ] Galvanized Metal [ ] Other:	[X] Good [ ] Fair [ ] Poor [ ] Destroyed	[ ] 1909-1912 [ ] 1913-1923 [X] 1924-1938 [ ] 1939-Present	5 PANEL - PP

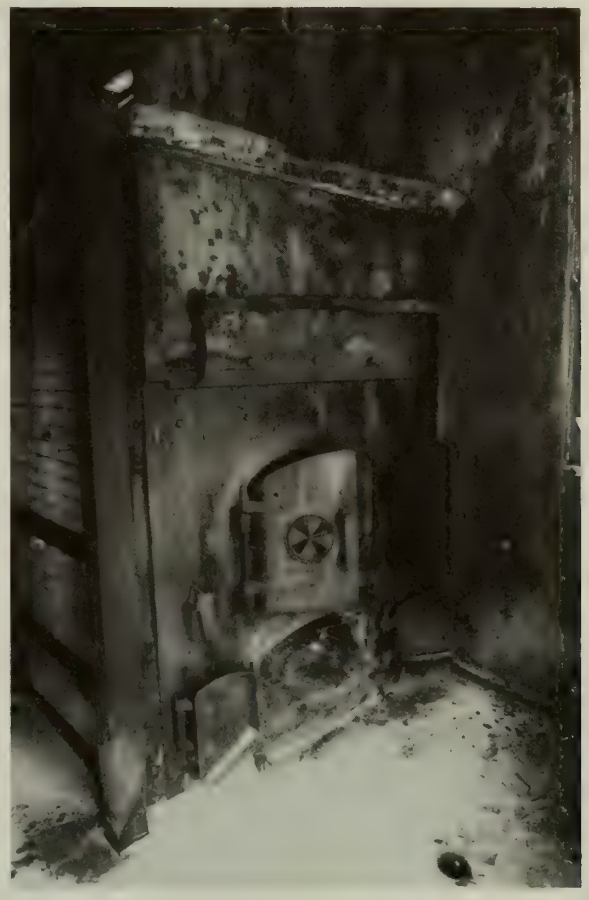
WESTERN INCINERATOR - VIEW N.

EASTERN INCINERATOR - VIEW N.

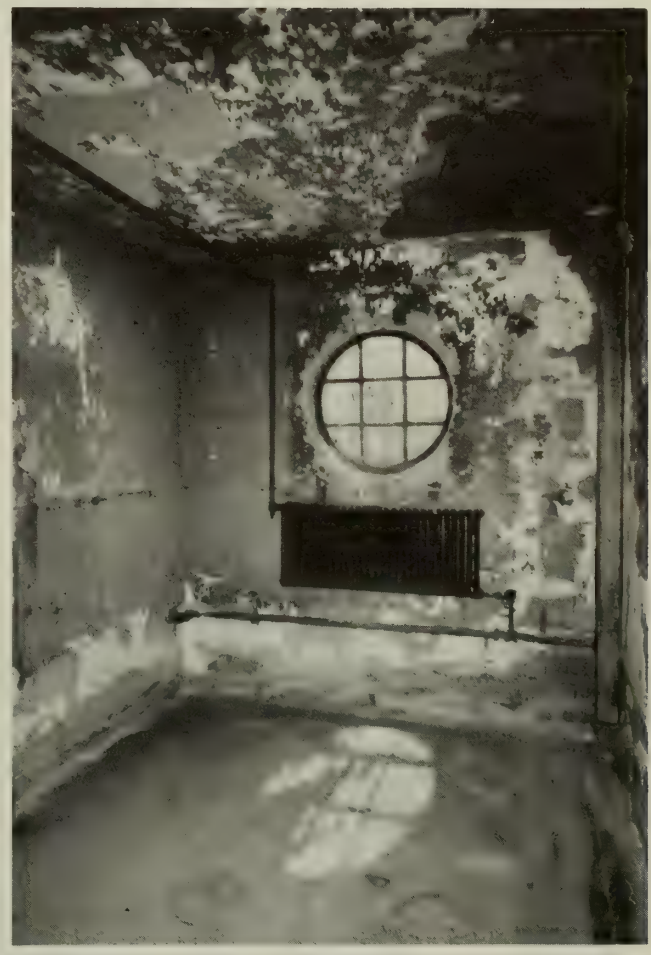
ROOM 103 - VIEW W.

Walls: Brick- peeling paint and minimum spalling on base of west wall. Plaster- poor condition. Exposed terra-cotta in room 103 on north and east walls and spalling occurs elsewhere.

Ceiling: Fair condition. Exposed lath in northwest corner of room 103 and surface spalling in room 101. Concrete ceiling is good.
